**SUBJECT: FINAL REMOVAL ASSESSMENT SAMPLING REPORT
DEFERIET PAPER MILL SITE
DEFERIET, JEFFERSON COUNTY, NEW YORK**

FINAL REMOVAL ASSESSMENT SAMPLING REPORT

DEFERIET PAPER MILL SITE Deferiet, Jefferson County, New York

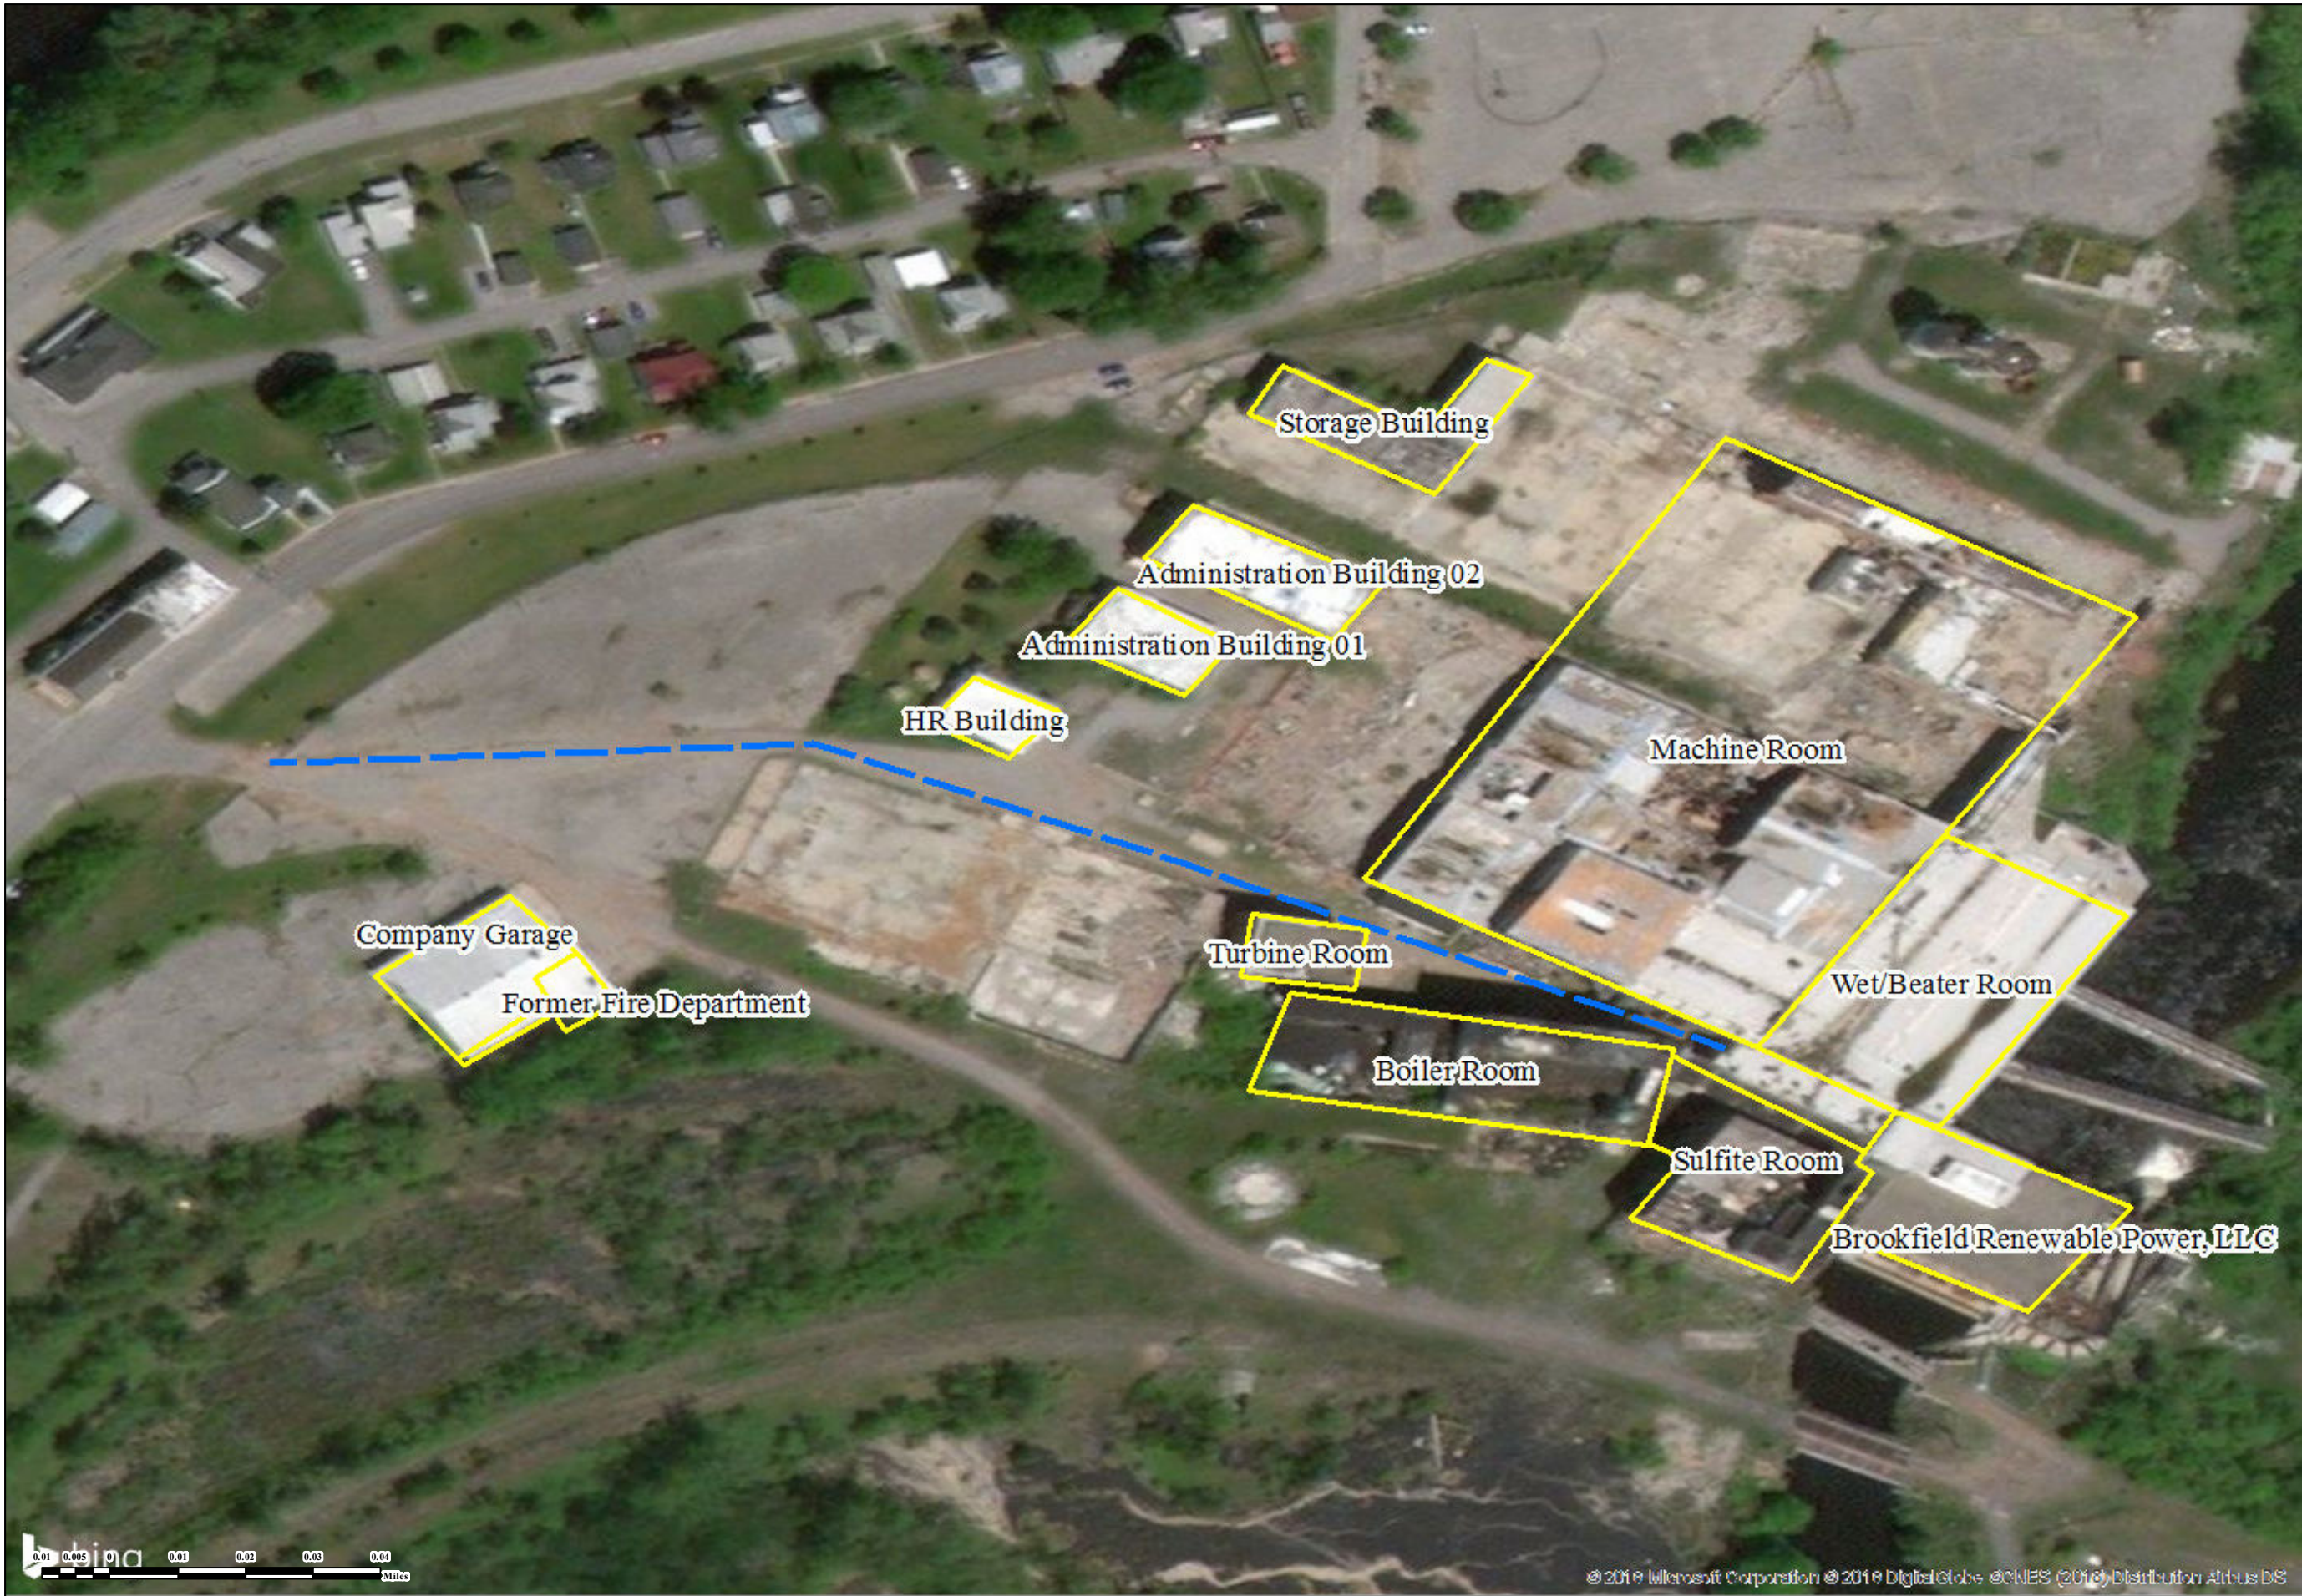
**FIGURE 2:
Site Layout Map**

Refer to Attachment A, Figure 1: Site Location Map and Figure 2: Site Layout Map.

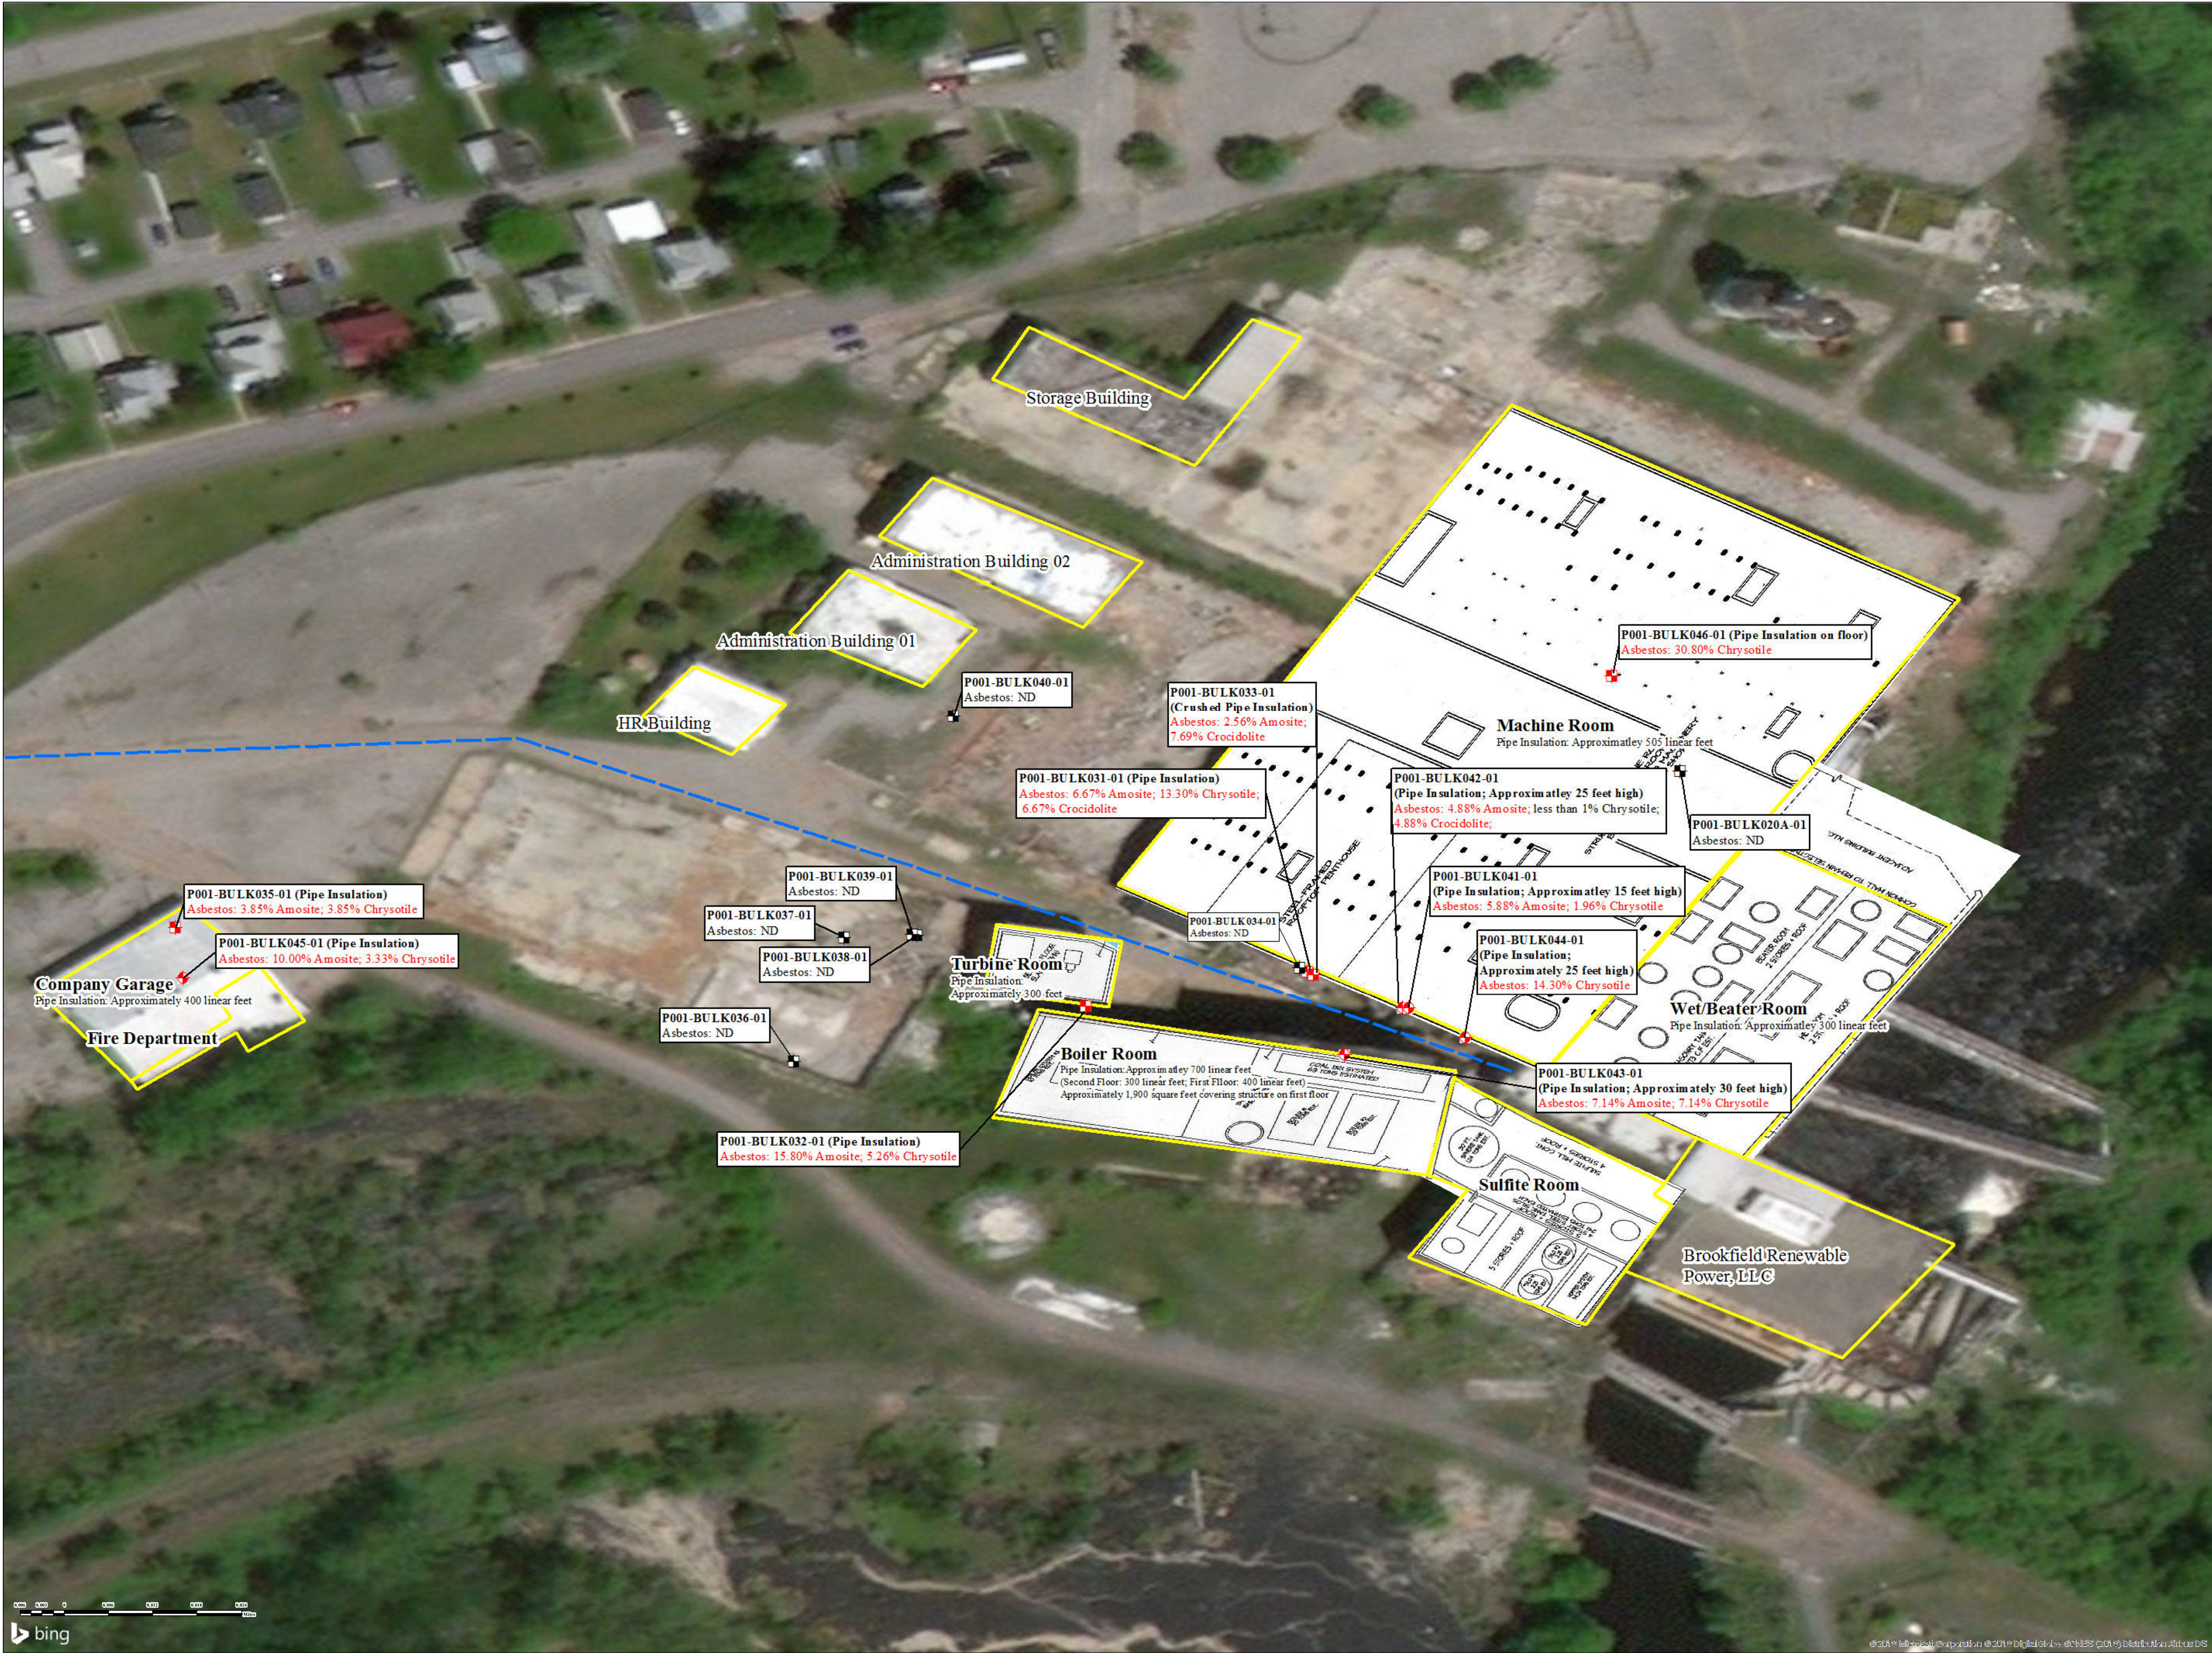
Figure 3: SACM Analytical Results and Pipe Insulation Estimates Map

A total of 2,205 linear feet of pipe insulation containing SACM was estimated in the surveyed buildings, including 300 linear feet in the turbine room, 400 linear feet in the former company garage building, 505 linear feet in the machine room, 300 linear feet in the wet/beater room, and 700 linear feet in the boiler room (400 linear feet on the first floor and 300 linear feet on the second floor). In addition, an estimated 1,900 square feet of insulation containing SACM appeared to be covering a large structure on the first floor of the boiler room. Furthermore, there is an area in the boiler room where an unmeasured stockpile of insulation containing SACM was observed during the Phase 1 Removal Assessment in June 2017.

SACM Samples Collected from the First Floor and Ground Level - No Asbestos Detected.
SACM Samples Collected from the First Floor and Ground Level - Asbestos Detected.
SACM Samples Collected from Elvated Locations - Asbestos Detected

Notes
SACM -Suspected Asbestos Containing Material
ND - Non-Detect
Sample Results greater than 1% asbestos are presented in red font.

Validated analytical results of the bulk SACM samples analyzed for asbestos were compared with the EPA's National Emission Standards for Hazardous Air Pollutants (NESHAP) which defines ACM as materials containing more than 1 percent (%) asbestos. Based on validated analytical results, seven of the 17 SACM samples were reported as non-detect. Eight of the 10 samples detected with asbestos contained Amosite asbestos ranging from 2.56% to 15.8%, nine samples contained Chrysotile asbestos ranging from <1.0 % to 30.8%, and three samples contained Crocidolite asbestos ranging from 4.88% to 7.69%.

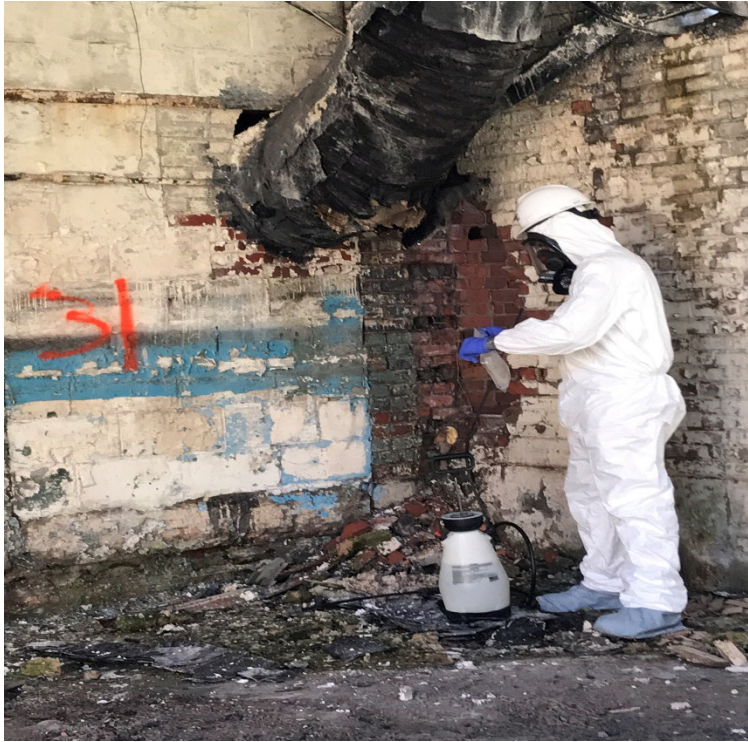
Photograph 1: View, facing north, of Weston Solutions, Inc., Removal Support Team 3 (RST 3) personnel collecting bulk suspect asbestos containing material (SACM) sample P001-BULK031-01 from pipe insulation near the exterior of machine room, in the vicinity of the easement area.

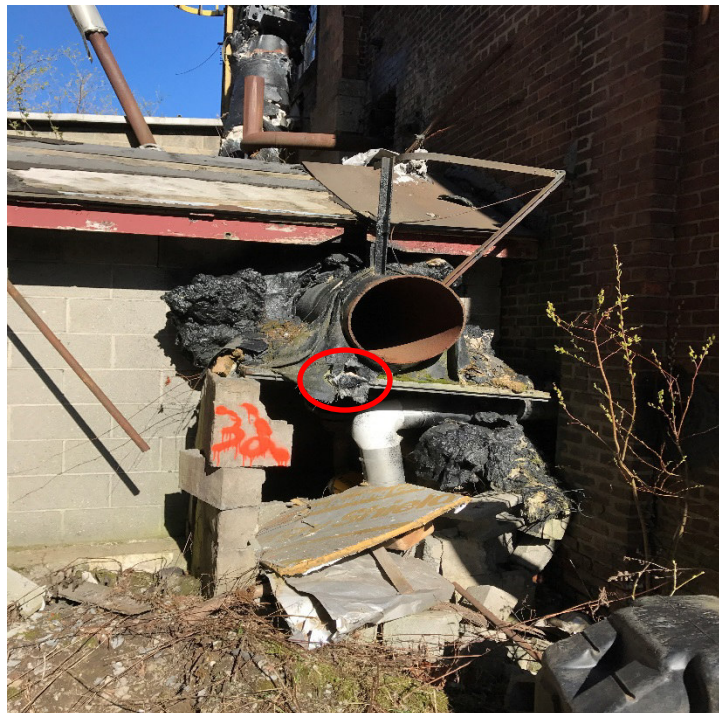
Photograph 2: View, facing west, of bulk SACM sample location P001-BULK032 located near the exterior of the turbine room, in the vicinity of the easement area.

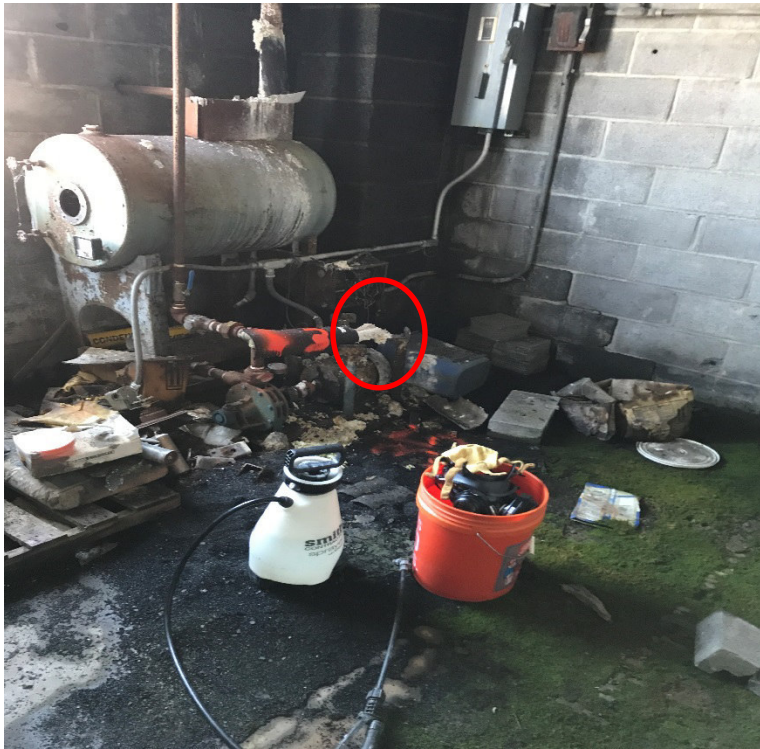
Photograph 3: View of P001-BULK035 located in the northern storage room of the company garage building.

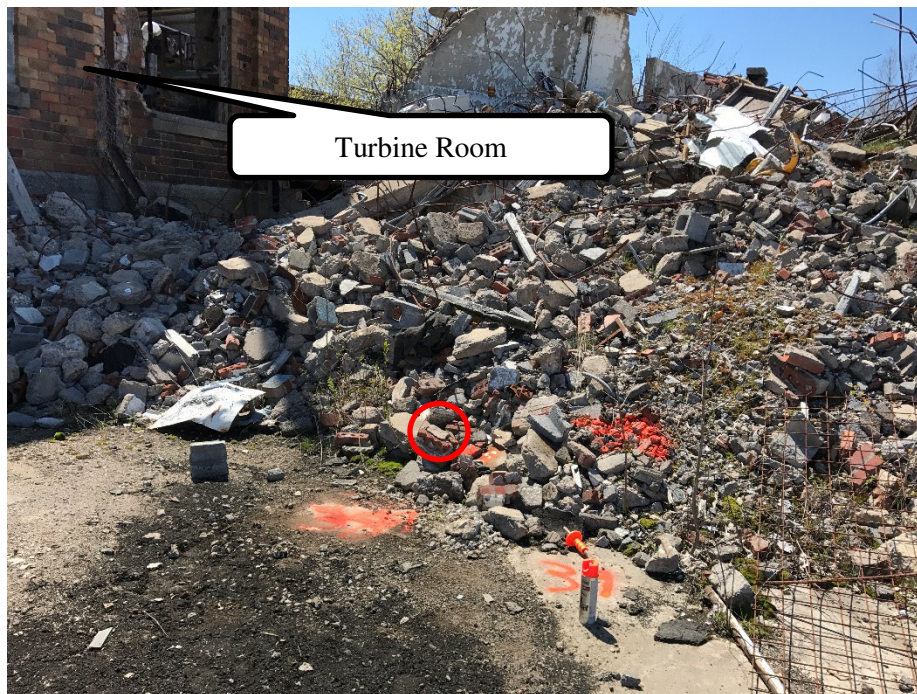
Photograph 4: View, facing south, of P001-BULK039 located in a debris pile adjacent to the turbine room.

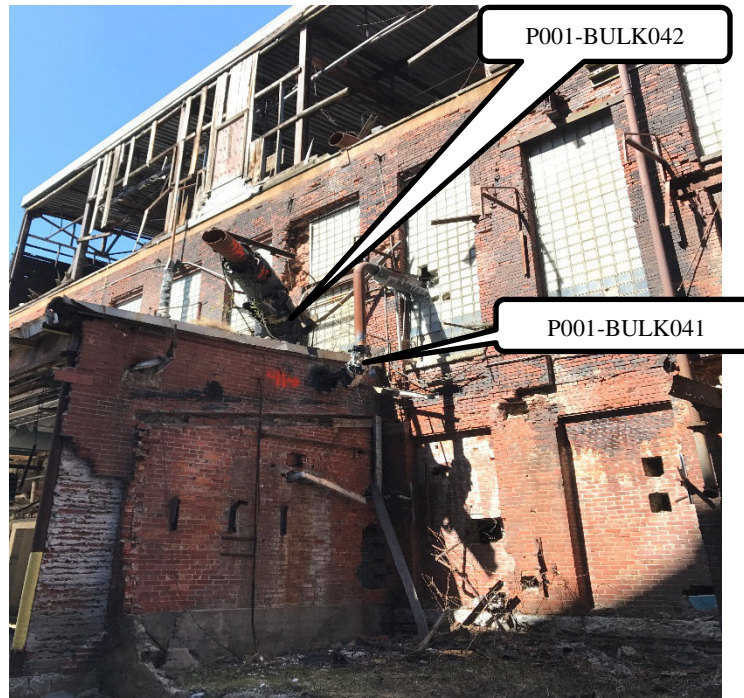
Photograph 5: View, facing northwest, of P001-BULK041 and P001-BULK042 located near the exterior of the machine room, in the vicinity of the easement area.

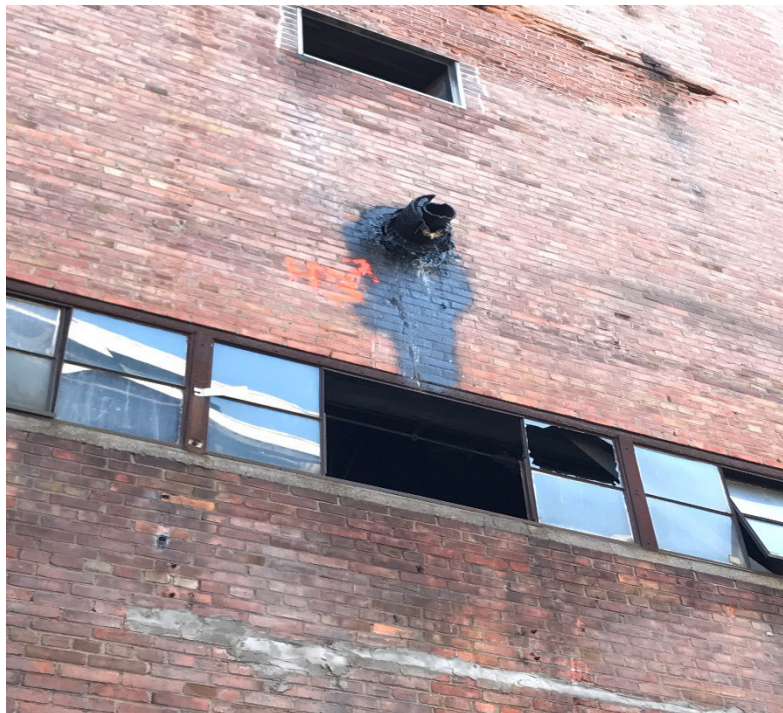
Photograph 6: View, facing south, of P001-BULK043 located on the exterior of the boiler room, in the vicinity of the easement area.

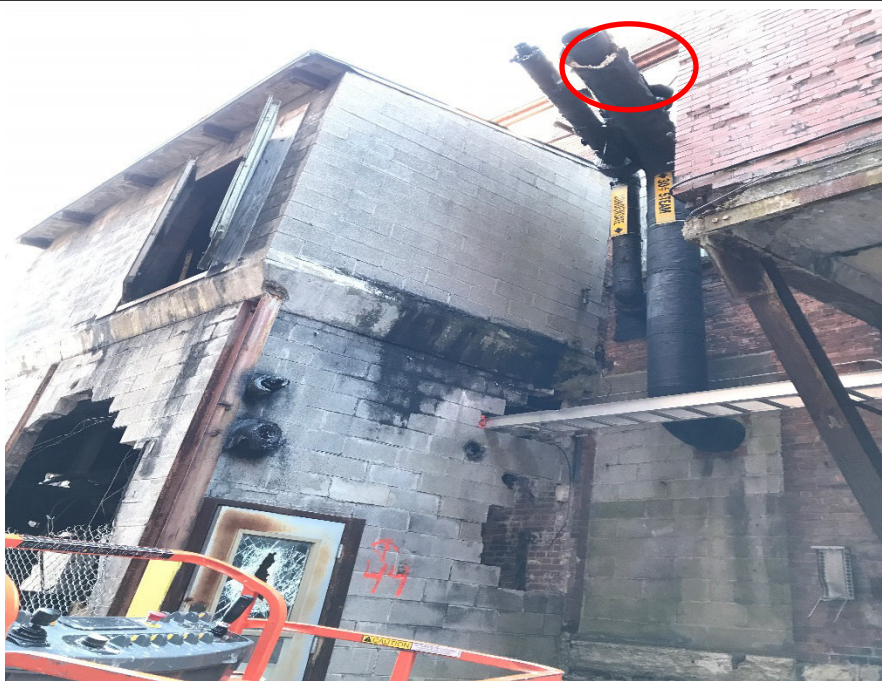
Photograph 7: View, facing northwest, of P001-BULK044 located near the exterior of the machine room, in the vicinity of the easement area.

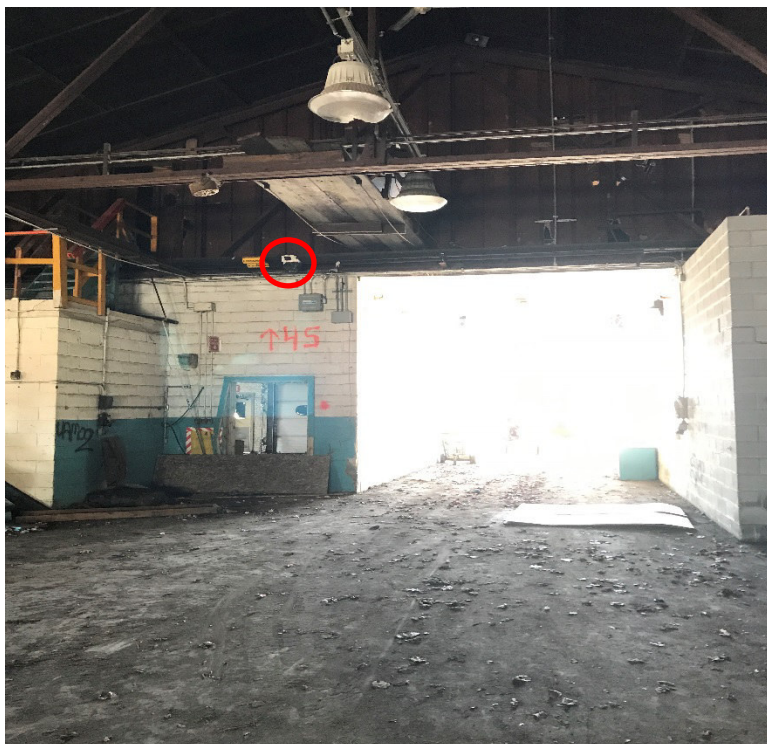
Photograph 8: View, facing northeast, of P001-BULK045 located in the company garage building, after sample collection.
